Manhole Inspection Summary

Manhole # S27M__013MH

Location Address: **1143 W.Cross St**

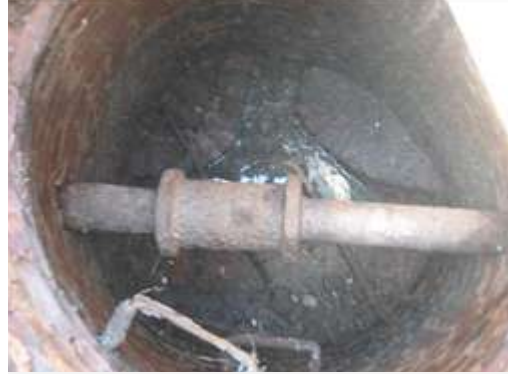
Top View

bh - unknown pipe (old water or gas?)
manhole needs cleaning

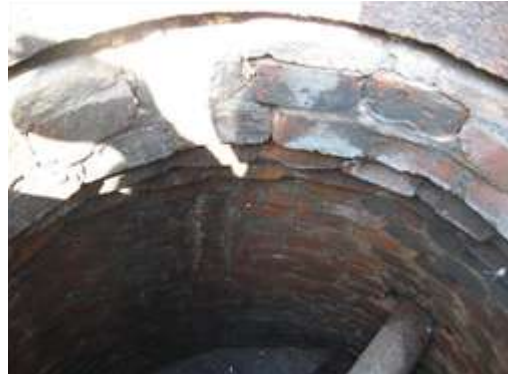
Defect 3

Condition: ☐ Sound ☒ **Cracked** ☐ Root Intrusion ☒ **Loose Brick** ☒ **Deteriorated**

Infiltration: ☐ None ☐ Joint ☐ Cracks ☒ **Mortar** ☐ Roots ☒ **Wall**

Deterioration under frame, corbel
infiltration evidence along wall

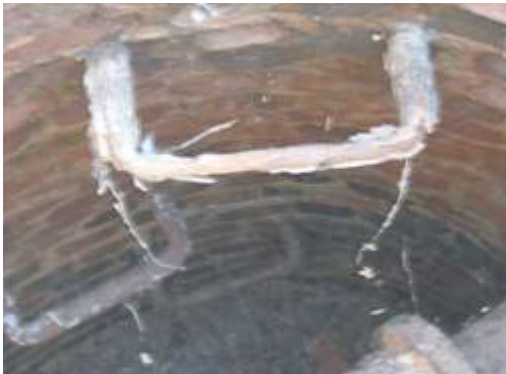
Defect 2

Steps Count: **3** Missing: **0** ☒ **Corroded**

corroded steps

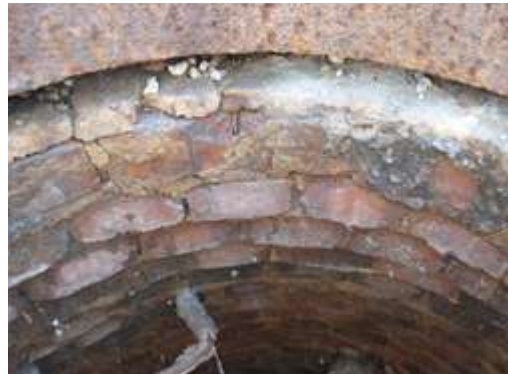
Defect 1

loose bricks, cracked and deteriorating
chimney

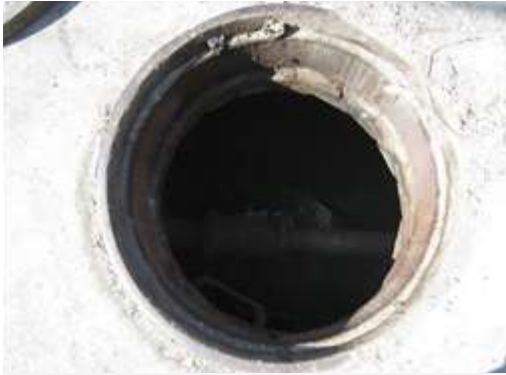
Defect 6

frame offset .5"

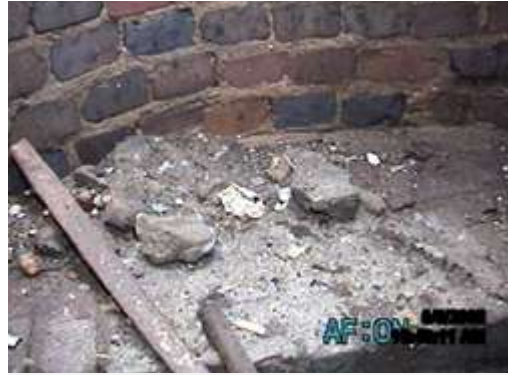
Defect 5

Condition: ☐ Sound ☐ Cracked ☐ Root Intrusion ☐ Deteriorated ☐ Leaks ☒ **Debris**

Debris on bench

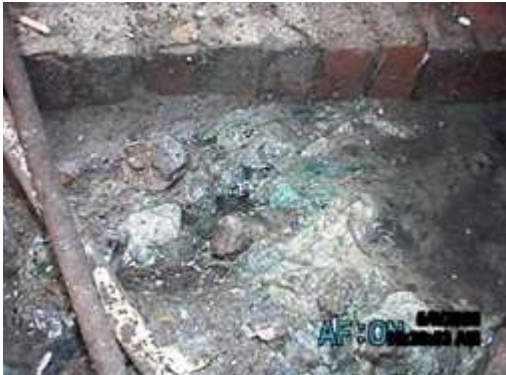
Defect 4

Condition: ☐ Sound ☐ Cracked ☐ Root Intrusion ☐ Deteriorated ☐ Leaks ☒ **Debris**

heavy debris and sludge in channels

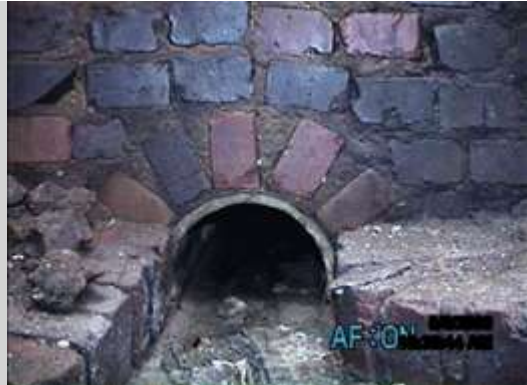
12 O'Clock Outflow

Pipe Height: **8.4** (in.) Rod and Bar (Angled)
Pipe Material: **Clay** ☐ Pipe Lined
Invert Depth: **6.87** (ft.) Flow Characteristics: **Slow**
Deposits: ☐ None ☐ Mud ☒ **Sludge** ☒ **Debris** ☐ Grease
Silt Depth: **5** (in.) Deposits Extent: **Heavy**
Infiltration: **None** Pipe Seal Cond: **Sound**

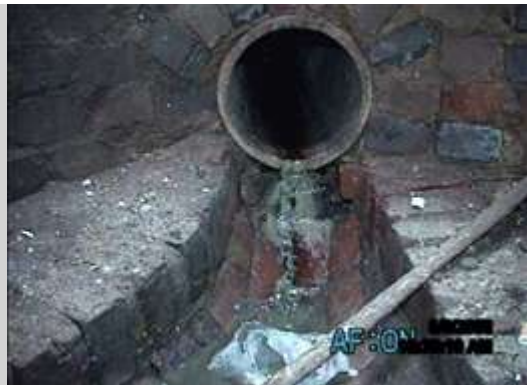
3 O'Clock Inflow

debris in channel

Pipe Height: **8.4** (in.) Rod and Bar (Angled)
Pipe Material: **Clay** ☐ Pipe Lined
Invert Depth: **6.12** (ft.) Flow Characteristics: **Slow**
Deposits: ☐ None ☐ Mud ☒ **Sludge** ☒ **Debris** ☐ Grease
Silt Depth: **5** (in.) Deposits Extent: **Heavy**
Infiltration: **None** Pipe Seal Cond: **Sound**

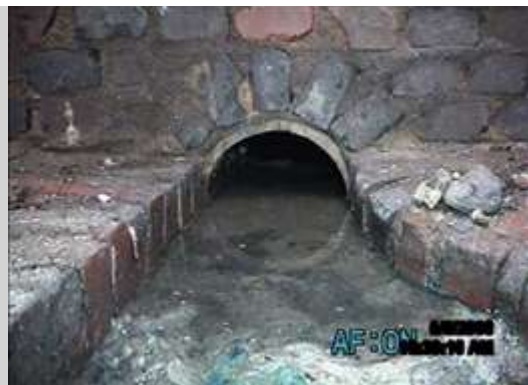
9 O'Clock Inflow

Deposits: ☐ None ☐ Mud ☒ **Sludge** ☒ **Debris** ☐ Grease

Silt Depth: **5** (in.) Deposits Extent: **Heavy**
